SITE 023 TRACK 1 DECISION DOCUMENTATION PACKAGE, OU 10-08

DECISION DOCUMENTATION PACKAGE COVER SHEET

Debris in Birch Creek Drainage Gravel Pit

023

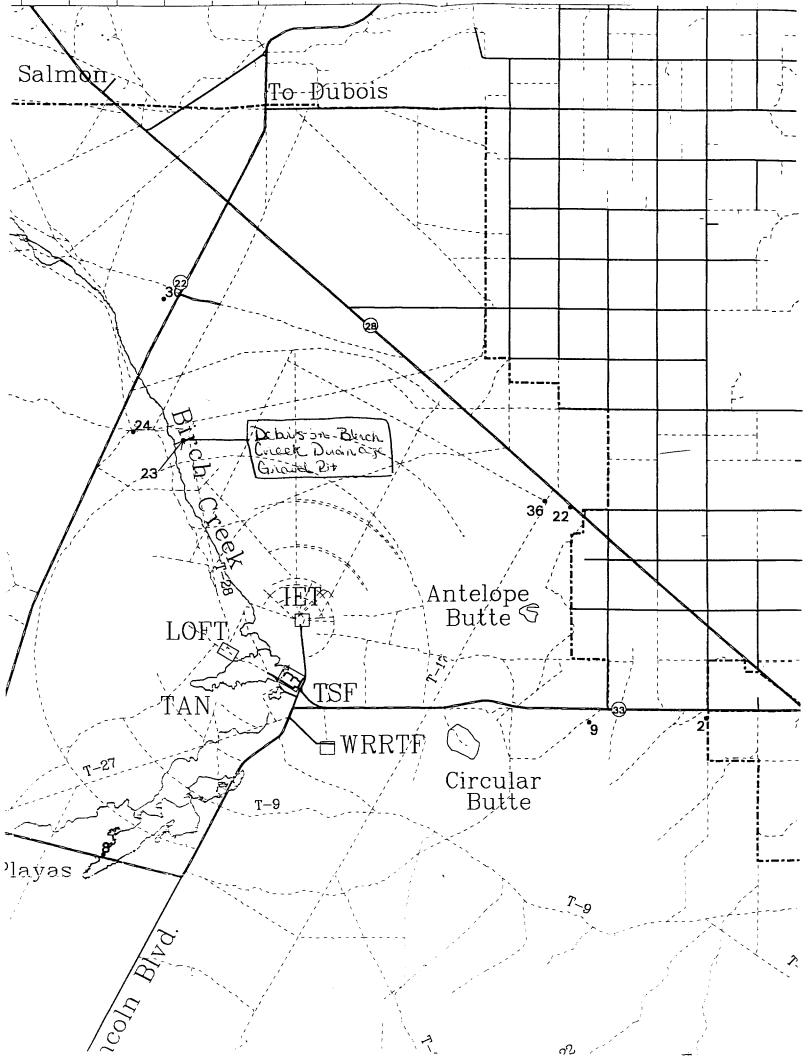
Photographs of Site #023

Investigations revealed that Site 023 includes two aluminum irrigation pipes, located near a large gravel pit. The pipes are agricultural in nature, weathered, and likely related to former farming or grazing operations.

There is no visual evidence of hazardous constituents, nor evidence that waste has recently been disposed of at this site. There is no evidence of disturbed vegetation, or stained or discolored soil. The ground surface shows well-established native grasses and sagebrush. The description of the site conditions is based on recent site investigations and INEEL historical research; no field screening or sample data exist for this site.
